Common Reasons for O-Ring Failure

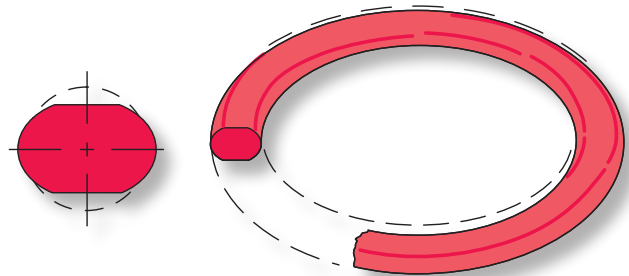
Illustration 8.1

Compression Set

Failure Pattern: Common to both static and dynamic seals, compression set failure produces flat surfaces on both sides of the O-ring's cross section.

Problem Sources: Selection of elastomer with poor compression set properties... Low heat resistance of material... Excessive swelling of O-ring material in system fluid... Too much squeeze to achieve seal... Incomplete curing (vulcanization) of O-ring material during production.

Suggested Solutions: Employ a low set elastomer... Specify an O-ring material that resists both operating and friction generated heat... Re-check O-ring material compatibility with system chemicals... Reduce O-ring squeeze if possible... Inspect incoming O-rings for correct physical properties.

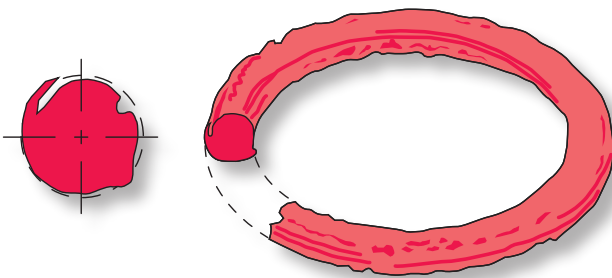
Illustration 8.2

Extrusion & Nibbling

Extrusion & Nibbling Failure Pattern: Typical of high pressure systems, this pattern can be identified by the many small bites (nibbles) taken from the O-ring on the low pressure (downstream) side.

Problem Sources: Excessive clearances... Excessive system pressure... O-ring material too soft... Degradation of O-ring by system fluid... Irregular clearance gaps caused by eccentricity... Improper machining of O-ring gland (sharp edges)... O-ring size too large for gland.

Suggested Solutions: Decrease gland clearances by machining... Use back-up rings to prevent extrusion... Use harder O-ring material... Re-check elastomer compatibility with system chemicals... Increase rigidity and improve concentricity of metal components... Break sharp edges of gland to a minimum radius of .005"... Install proper size O-ring... Consider a reinforced composite seal such as rubber-bonded-to-metal.

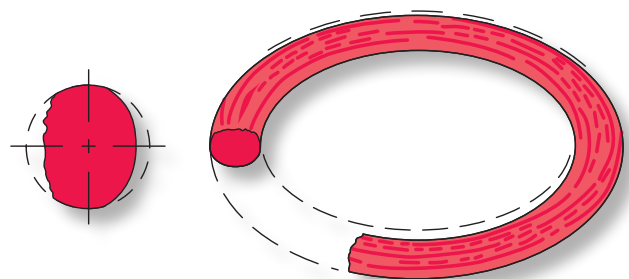
Illustration 8.3

Abrasion

Failure Pattern: Occurring primarily in dynamic seals involving reciprocating, oscillating, or rotary motion, this failure pattern can be identified by a flattened surface on one side of the O-ring's cross section.

Problem Sources: Metal surfaces too rough (acting as an abrasive)... Metal surfaces too smooth causing inadequate lubrication... Poor lubrication ... Excessive temperatures... System contaminated with abrasives.

Suggested Solutions: Use recommended metal finishes... Provide adequate lubrication (consider internally-lubed O-rings)... Check material compatibility with system temperature... Eliminate abrasive contamination with filters and/or wiper seals ... Consider change to a more abrasive resistant O-ring material such as carboxylated nitrile or urethane (see Section 5, Material Selection Guide).

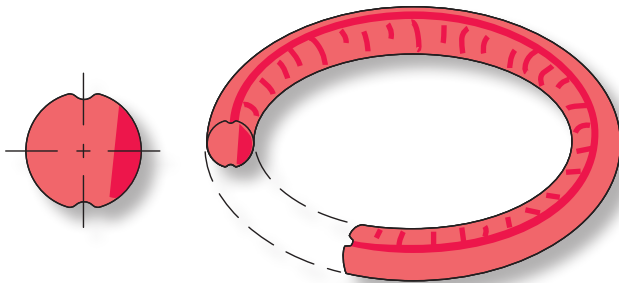
Illustration 8.4

Heat Hardening & Oxidation

Failure Pattern: Seen in both static and dynamic seals, the surface of the O-ring appears pitted and/or cracked, often accompanied by the flatness of high compression set.

Problem Sources: Excessive temperature causing elastomer hardening, evaporation of plasticizers and cracking from oxidation.

Suggested Solutions: Specify high temperature O-ring materials with antioxidants... Lower the operating temperature.

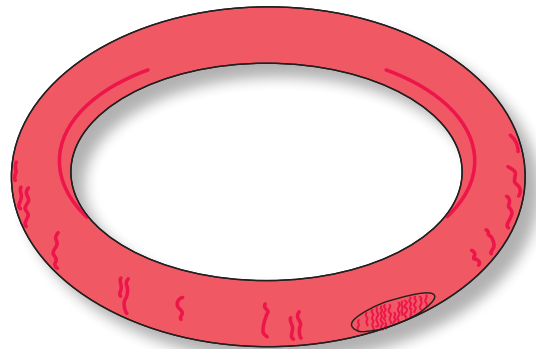
Illustration 8.5

Installation Damage

Failure Pattern: Occurring in both static and dynamic seals, this failure mode is marked by short cuts, notches, a skinned or peripherally peeled surface.

Problem Sources: Sharp edges on mating components of the O-ring gland... Sharp threads over which the O-ring must pass during assembly ... Insufficient lead-in chamfer... Oversize O-ring ID on piston... Undersize O-ring ID on rod... Twisting or pinching of O-ring during installation... No O-ring lubrication during installation... Low tear resistant elastomers such as Silicone.

Suggested Solutions: Break all sharp edges... Cover threads with tubes or tape during O-ring installation... Provide a 15-20° lead-in chamfer... Install correctly sized O-rings and use lubrication during assembly.

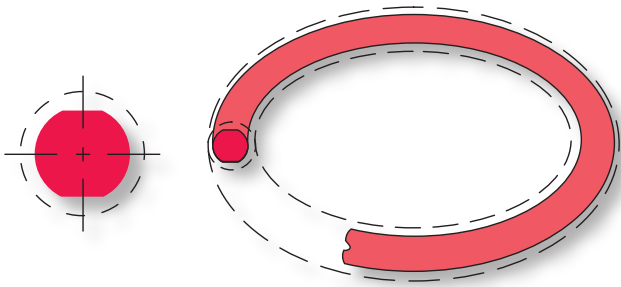
Illustration 8.6

Plasticizer Extraction

Failure Pattern: Occurring in both static and dynamic seals, primarily in fuel system service, this failure pattern is marked by loss of physical volume.

Problem Sources: Extraction of plasticizer by system chemicals.

Suggested Solutions: Employ a chemically compatible O-ring material. **Refer to the “Chemical Compatibility” table found on our website in Section 6.**

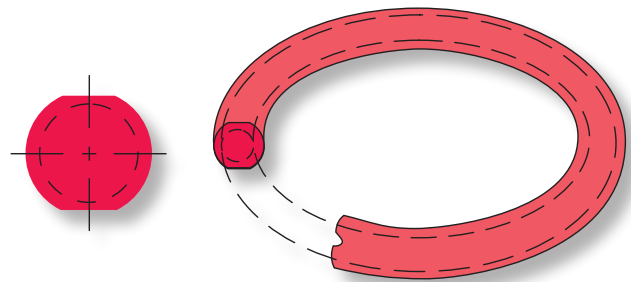
Illustration 8.7

Excessive Swell

Failure Pattern: Easily identified by a marked increase in seal dimensions and occurring in both static and dynamic situations. Results in a reduction of physical properties and can result in improper sizing between seal and gland. Dynamic applications are especially prone in that friction accelerates seal failure.

Problem Sources: Like a sponge, the seal absorbs the surrounding fluids and swells to the point of malfunction because of incompatibility between seal compound and system environment (i.e. chemical incompatibility, high humidity, etc.).

Suggested Solutions: Employ a chemically compatible O-ring material. **Refer to the “Chemical Compatibility” table found on our website in Section 6.**

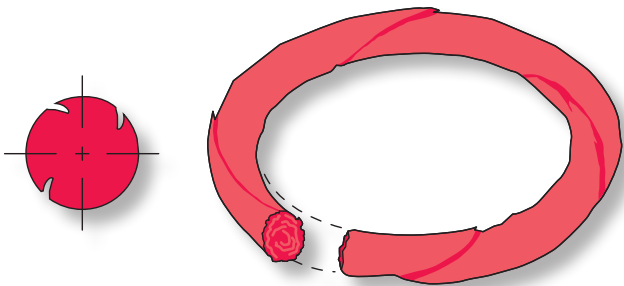
Illustration 8.8

Spiral Failure

Failure Pattern: Generally found on long stroke, hydraulic piston seals, the surface of the O-ring exhibits a series of deep, spiral 45 degree angle cuts.

Problem Sources: Caused when some segments of the O-ring slide while other segments simultaneously roll. At a single point on its periphery, the O-ring gets caught on an eccentric component, or against the cylinder wall, causing twisting and development of 45 degree angle, surface cuts.

Contributing Conditions Include: Eccentric components... Wide clearance combined with side loads... Uneven surface finishes... Inadequate lubrication... Excessive O-ring material softness... Too slow stroke speeds.

Suggested Solutions: Check for out-of-round cylinder bore... Decrease clearance gap... Machine metal surfaces to 10-20 micro-inch finish... Improve lubrication (consider internally-lubed O-rings)... Increase O-ring material hardness and/or cross section... Employ anti-extrusion back-up rings.

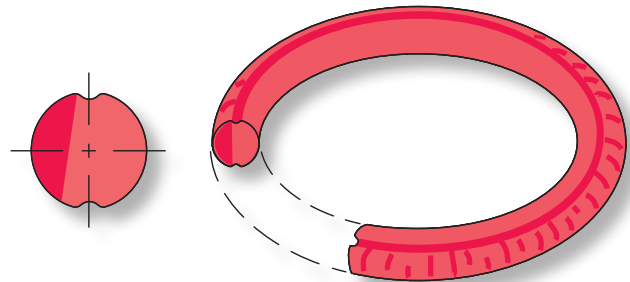
Illustration 8.9

Weather or Ozone Cracking

Failure Pattern: Occurring in both static and dynamic seals exposed to atmospheres containing ozone and other air pollutants, this failure mode is marked by the appearance of many small surface cracks perpendicular to the direction of stress.

Problem Sources: Ozone attack of the polymer chains causing O-ring cracking.

Suggested Solutions: Employ O-ring elastomers that are resistant to ozone attack. See Section 6, "General Properties Of O-Ring Elastomers".

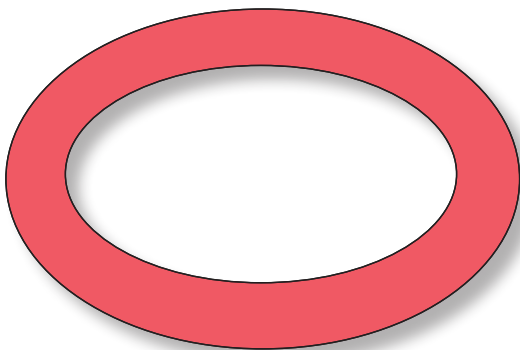
Illustration 8.10

Failure Without Visible Evidence on Seal

Failure Pattern: Of the various types of seal failure, this is among the hardest to diagnose because the result of the problem is not visible on the O-ring.

Problem Sources: Lack of compression... Tolerance stack-up... Eccentric components... Parting lines/flash... Improper seal/gland volume relationship.

Suggested Solutions: Maintain recommended compression range for the application... Identify the amount of stretch as it reduces the O-ring cross section with increased stretch... Determine the component tolerance stack-up as it directly affects the seal cross section... Consider maximum component shift in design to ensure that compression is still contained within recommended compression range... Avoid parting lines in O-ring grooves as they tend to be areas of flash and mismatch... Ensure that the O-ring gland volume surpasses the O-ring volume to allow for seal expansion without seal detriment.

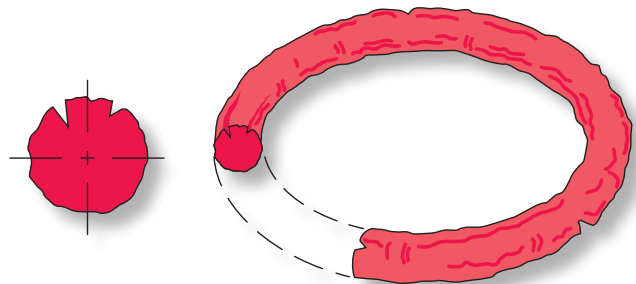
Illustration 8.11

Explosive Decompression

Failure Pattern: Marked by random short splits or ruptures going deep into the O-ring's cross section. When the O-ring is first removed, the surface may also be covered with small blisters.

Problem Sources: Absorption of gas by O-ring while operating in high pressure conditions. Subsequent rapid decrease in system pressure traps gas within the O-ring's micropores, causing surface blisters and ruptures as the gas escapes.

Suggested Solutions: Increase time for decompression... Increase material hardness to 80-95 durometer range... Reduce O-ring cross sectional size... Specify a decompression resistant material, such as Nitrile.
